Field Report #3

Pocahontas Building Coordination

Hill Studio Project # 0908.06

January 28, 2011

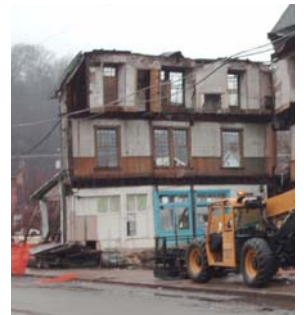
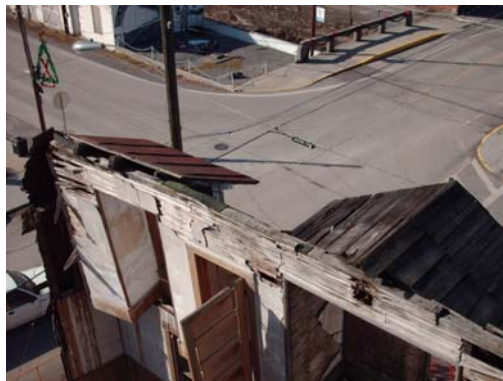
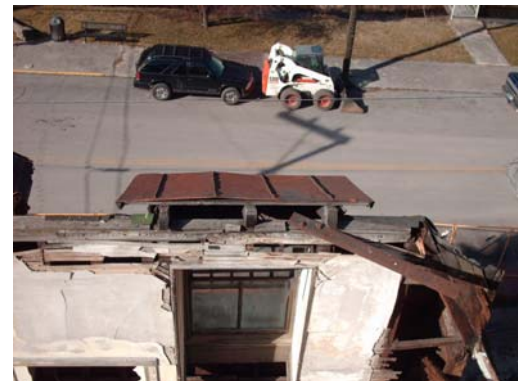
1. From viewing the façade at the top (plan view) a noticeable bowing out can be seen. This will be difficult to stabilize and may be brought back into a straight condition but correcting the bowing out of the facade is not guaranteed.

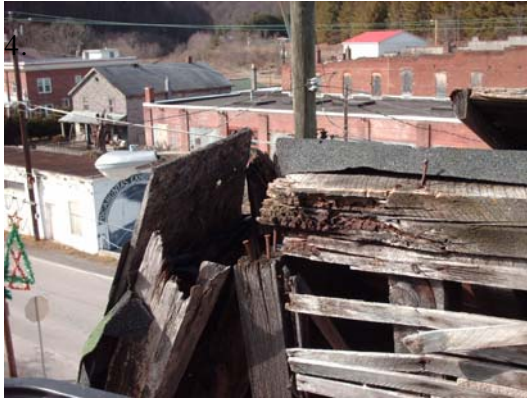
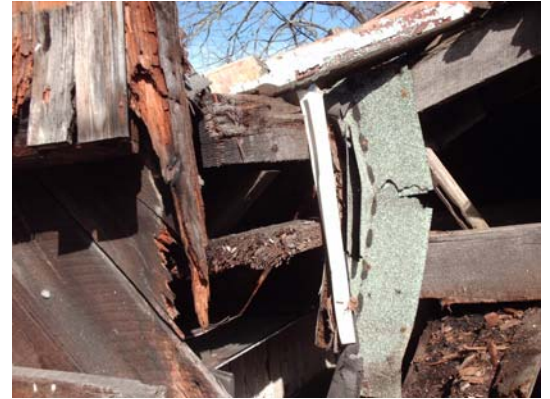
3. The wing walls on both sides of the façade will need to be removed as they have deteriorated beyond repair.

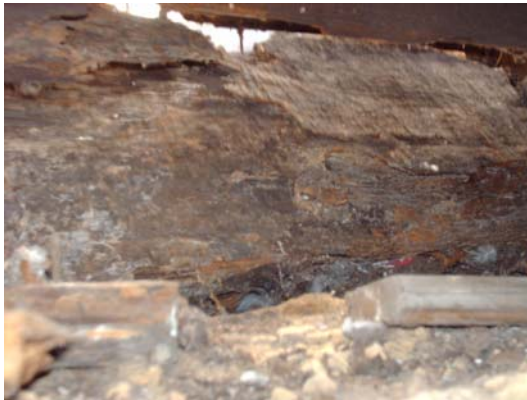
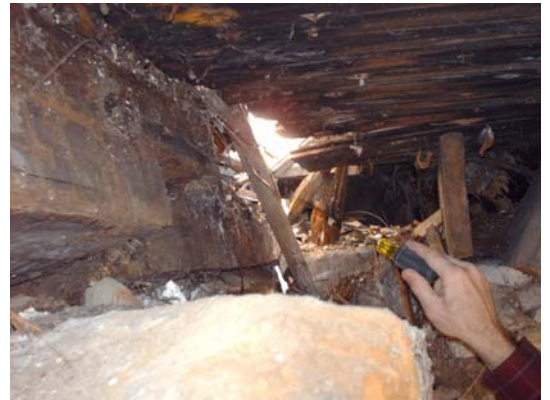
4. On the bottom of the façade where the wood meets the stone foundation there is considerable rotten wood. This will need to be replaced as part of the stabilization process and is additional work.

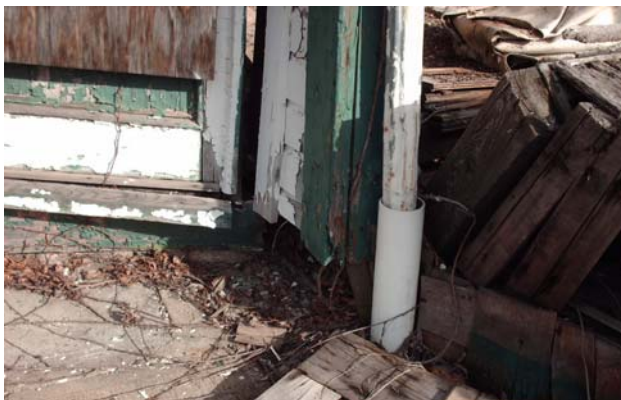
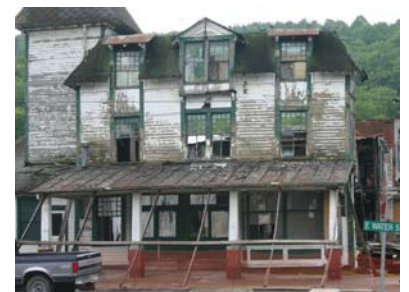
1. The right side of the façade appears to have settled due to the rotten wood on the right side. Repair of this wood and the jacking up of the facade with hydraulic lifts can help to repair this condition and may straighten out the other parts of the façade, and will be additional work.

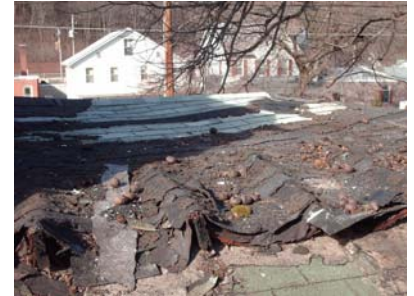
1. The roof of the Café is in need of extensive replacement and repair.
2. There isn't much rotted wood on the Café and is fixable.

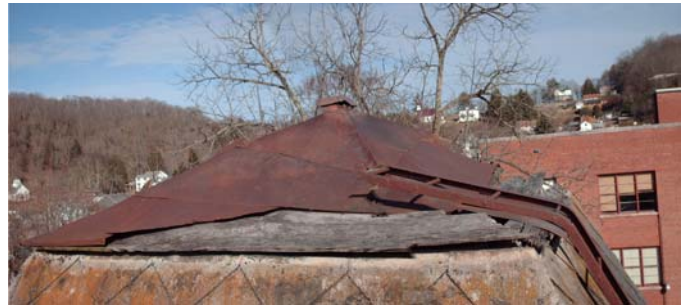
1. The top, slightly sloping part of the roof will need to be replaced. The shingles making the mansard type part of the roof appear to be in a good condition.

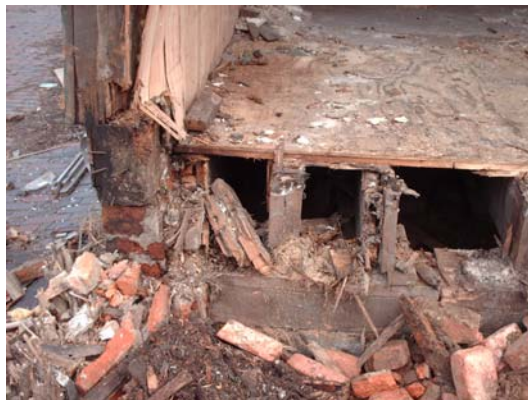
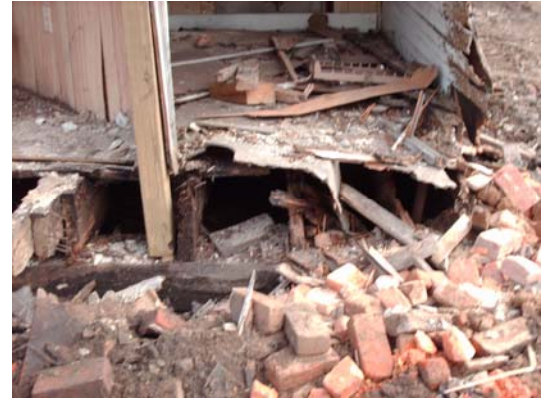
1. The grade beams and joists show some signs of rotten wood but it is fixable.

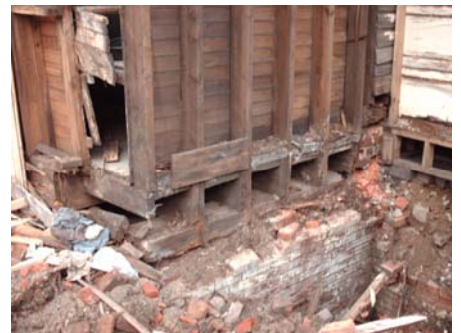
2. The southwest corner of the building has a rotten grade beam and is missing part of its structural framing but can be repaired.

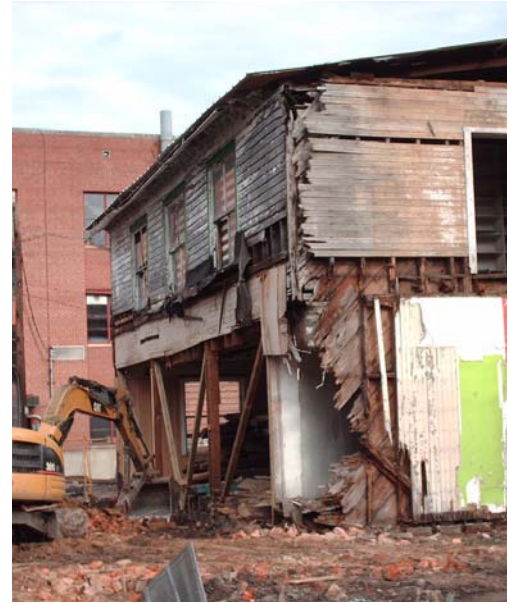
3. The northwest corner of the building has no corner support and the structural framing is either not there or is partially rotten. Stabilizing this corner will likely require some additional work.

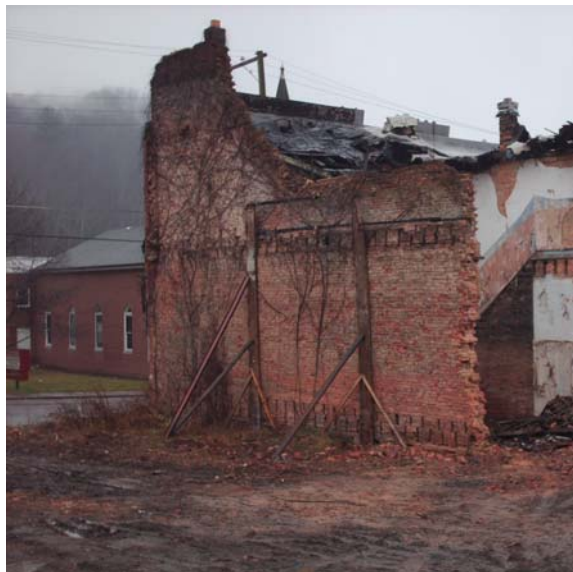
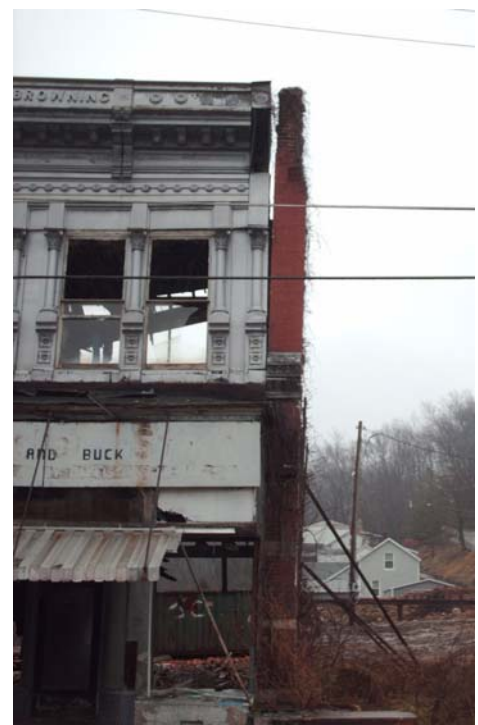
1. The southern most brick wall is in a very unstable condition. After reviewing its condition I recommend that it be removed and a new wall be reconstructed in its place which would be an additional cost.

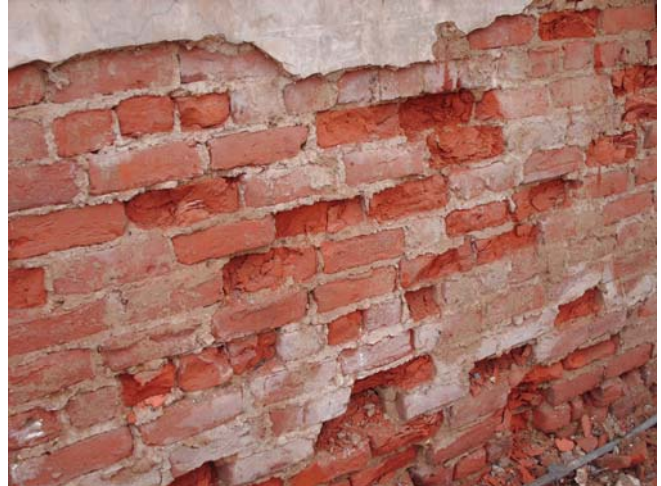
2. The brick of the two interior walls has deteriorated probably due to exposure to the weather. The mortar is soft and not holding the bricks in some places. And in other places the mortar is hard and the bricks have softened and fallen away. The brick walls themselves need to be stabilized and that will be an additional cost.
